Rugged Operating system on Linux (ROX) Release Notes v1.13.4

April 24th, 2009
Copyright © 2009 RuggedCom Inc.

Overview

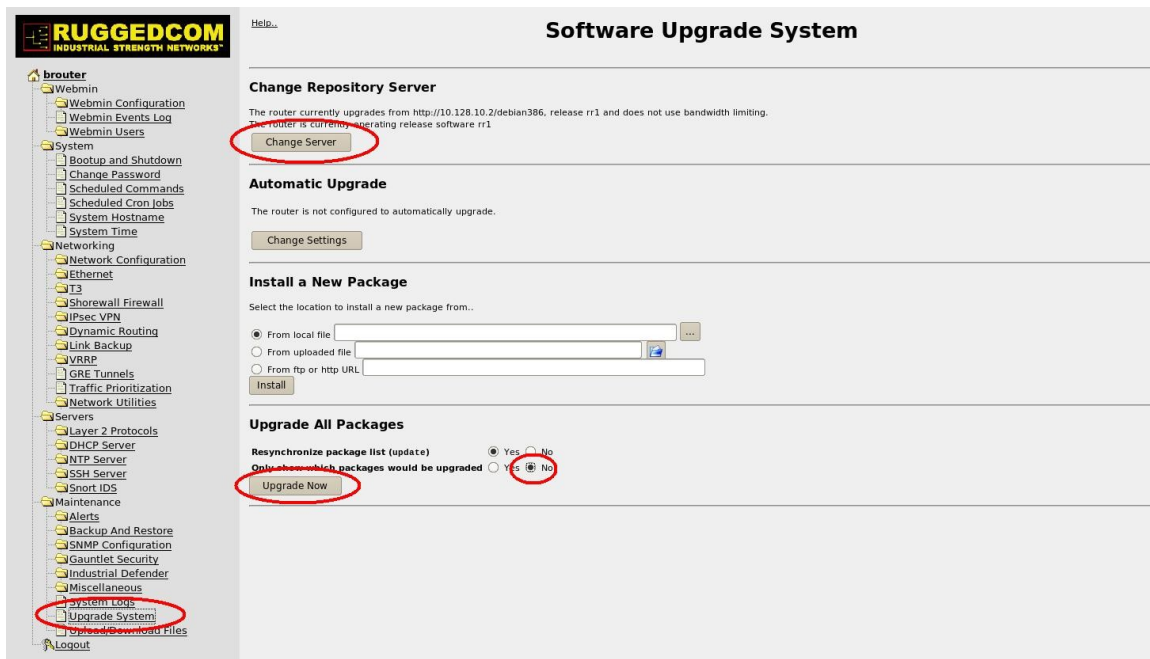
The upgrade procedure works by using a set of upgrade files accessible from a web server. These files are distributed in the form of a .zip archive and should be unpacked in a location on a web server that's accessible from the router. Using Webmin Upgrade -> System on a router, the configuration is made using 'Change Repository Server' to point to that location on the web server. Once done, a test run of the upgrade can be made by setting the 'Only show which packages would be upgraded' option to Yes and doing an 'Upgrade Now'. When everything is found satisfactory, setting the same option to No and doing an 'Upgrade Now' will actually launch the upgrade process. Depending on the nature of the upgrade, you might be asked to confirm if a reboot of the unit is deemed necessary. It is important that there are no power supply interruption during the time it takes for an upgrade to complete. The following illustration highlights the various options used in the process of upgrading a RuggedRouter.

Illustration 1: ROX Upgrade Process using Webmin
