Rugged Operating system on Linux (ROX) Release Notes v1.14.3

July 6th, 2010

ROX 1.14.3 - Overview

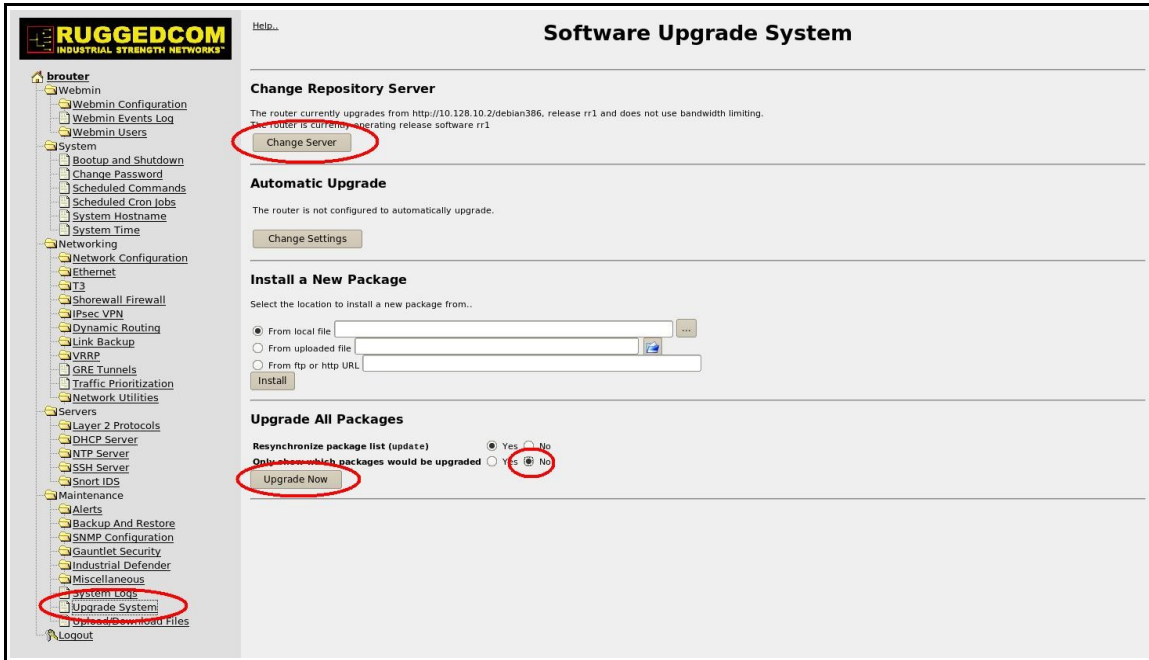
Illustration 2: Webmin Upgrade Information Page

It is important that there are no power supply interruption during the time it takes for an upgrade to complete. The following illustrations highlights the various options used in the process of

upgrading a RuggedRouter.

The upgrade procedure works by using a set of upgrade files accessible from a web server. These files are distributed in the form of a .zip archive and should be unpacked in a location on a web server that's accessible from the router. Using Webmin Upgrade -> System on a router, the configuration is made using 'Change Repository Server' to point to that location on the web server. Once done, a test run of the upgrade can be made by setting the 'Only show which packages would be upgraded' option to Yes (default setting) and doing an 'Upgrade Now'. When everything is found satisfactory, setting the same option to No and doing an 'Upgrade Now' will actually launch the upgrade process.
